MARINE INVESTIGATION REPORT
M00L0034

MAIN ENGINE FAILURE

GENERAL CARGO CARRIER *MILLENIUM YAMA*
ST. LAWRENCE RIVER
11 APRIL 2000

Report Number M00L0034

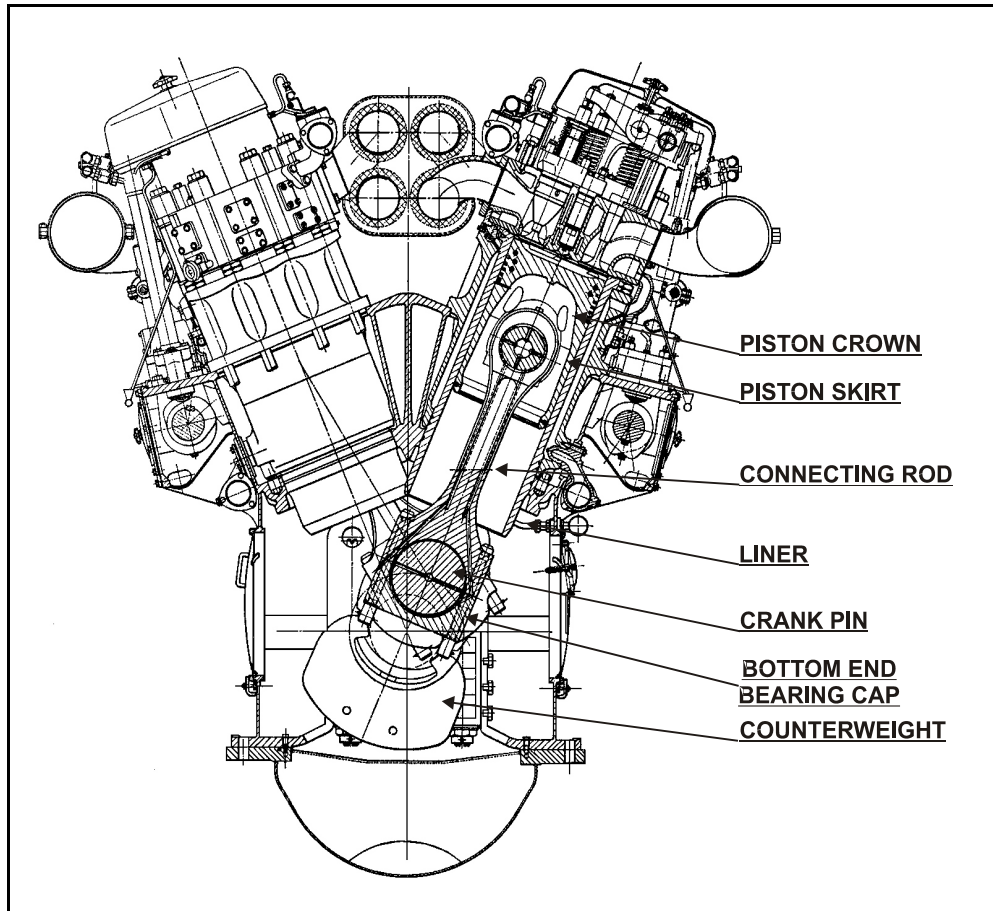
Figure 1. The main engine.

Inspection of the main engine revealed that the connecting rod (con-rod) had separated from piston No. 3.³ The piston crown had separated from the skirt, which was in pieces. The crankshaft was bent at the No. 4 main bearing. The exhaust valve and push rods for the exhaust and inlet valves in the No. 3 cylinder head were also bent. The No. 6 counterweight and the

piston end of the No. 3 con-rod were jammed between the crank pin and the bottom of the liner and the casing (see Figure 1).

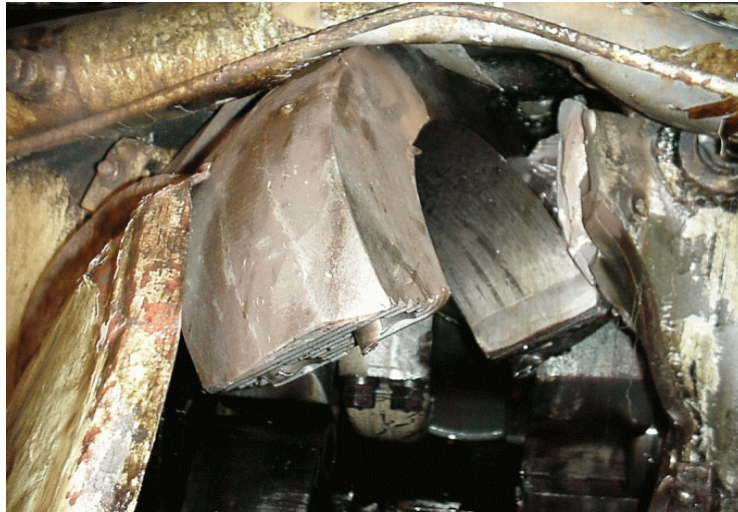
Photo 2. Bottom end of the No. 3 con-rod, *in situ*.

The bottom end of the No. 3 con-rod punched through the right side of the main engine, damaging the casing and inspection door at unit No. 9. The lube oil and coolant lines and the flexible coupling were also damaged (see Photo 2).

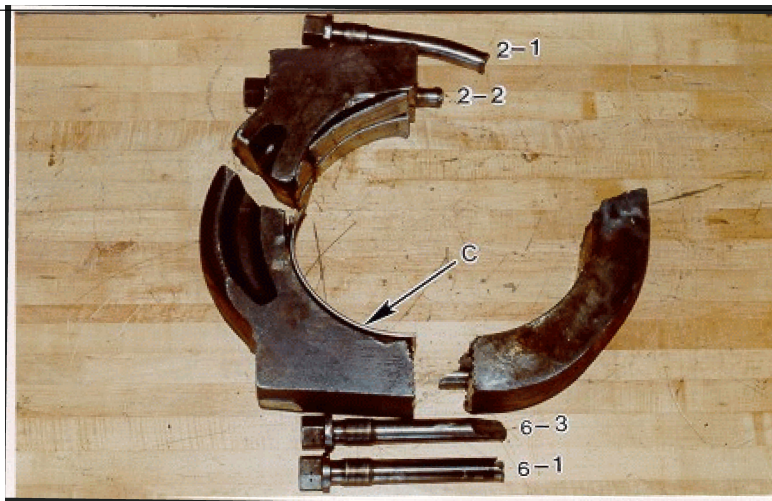
Photo 3. The four con-rod cap bolts, the two pieces of the broken cap, and part of the upper portion of the con-rod that was cut off with a torch. The letter "C" indicates the lower bearing shell that was broken in two. Bolts nos. 6-1 and 6-3 are not bent. Bolt No. 2-1 is deformed.

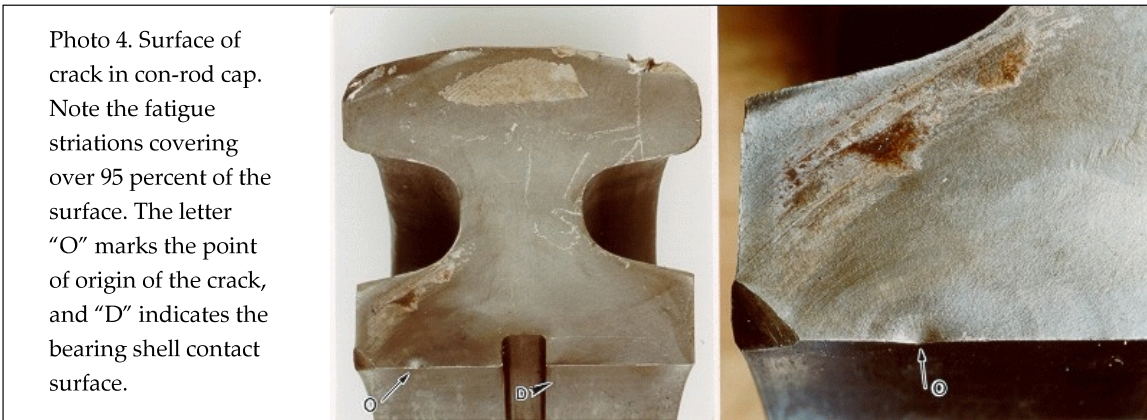
In most cases of con-rod detachment, the bottom end cap separates from the upper part of the con-rod, which is caused by a failure of either the securing bolt or the cap. The bolts usually fail in fatigue caused by unequal torquing.

The Board determined that the con-rod cap became detached from the con-rod due to a fracture and not due to failure of the bolts. It was noted that the crack developed in the thinnest section of the con-rod cap⁷. It originated in a corrosion pit on the contact surface with the bearing shell, then propagated to over 95 percent of the cap surface through high cycle fatigue. The cap subsequently failed in overload in the smallest section. The break-up of the cap caused the four bolts to fracture.

In this occurrence, the con-rod cap fractured near its centre. This seldom occurs, since the central portion is generally subjected to very little stress. Stresses are normally concentrated in the upper portion of the con-rod.

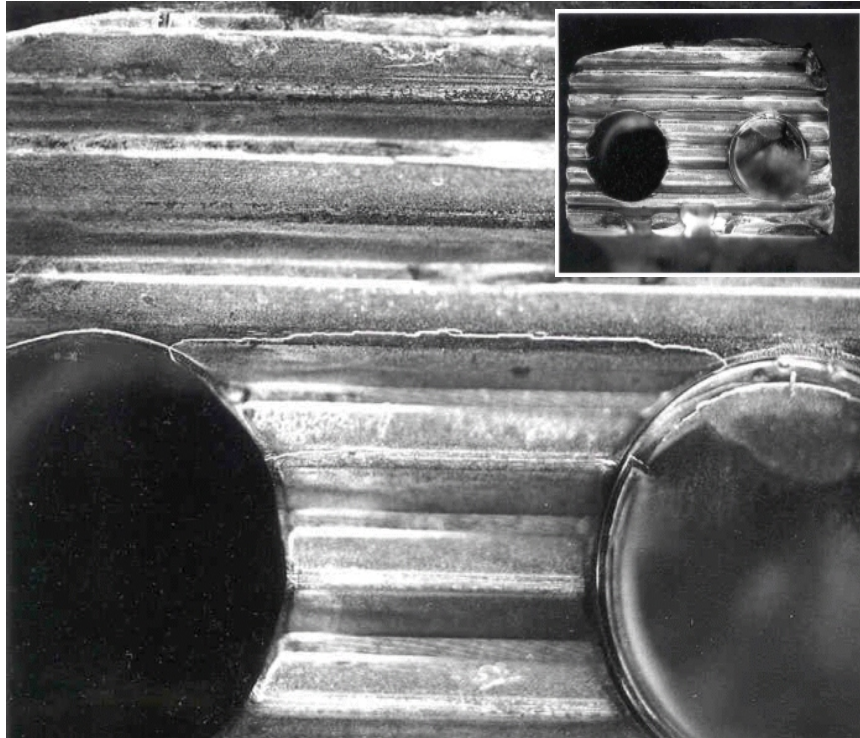
For instance, SEMT Pielstick prescribes that connecting rods be inspected regularly⁸ and recommends that a dye penetration test be conducted on the serrated area after 24,000 running hours, because of its susceptibility to cracks. Subsequent to this occurrence, TSB analysis on the connecting rod cap revealed that cracks were present in this serrated area, illustrating the importance of following manufacturer's recommended maintenance practices.

Photo 5. TSB Engineering Laboratory conducted a dye penetration test on the serrated area of the damaged con-rod cap. Cracking is clearly visible.
